# Inspection Report

123 Fake Street  
Chicago IL 60638

## Optimal Home Inspections

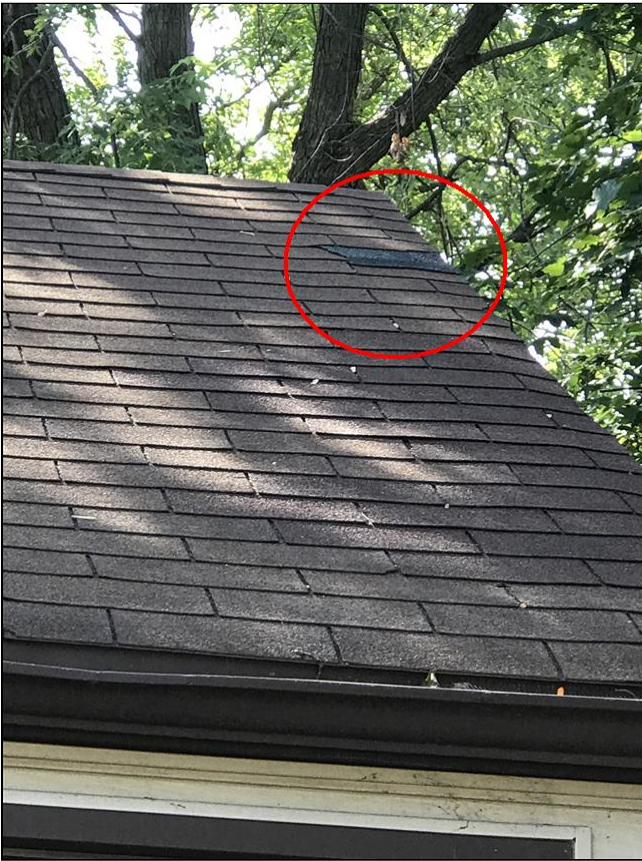
1.3 Item 1(Picture) Shingle missing from roof, which can cause water infiltration/deterioration. Have a qualified roofing contractor repair or replace as needed.

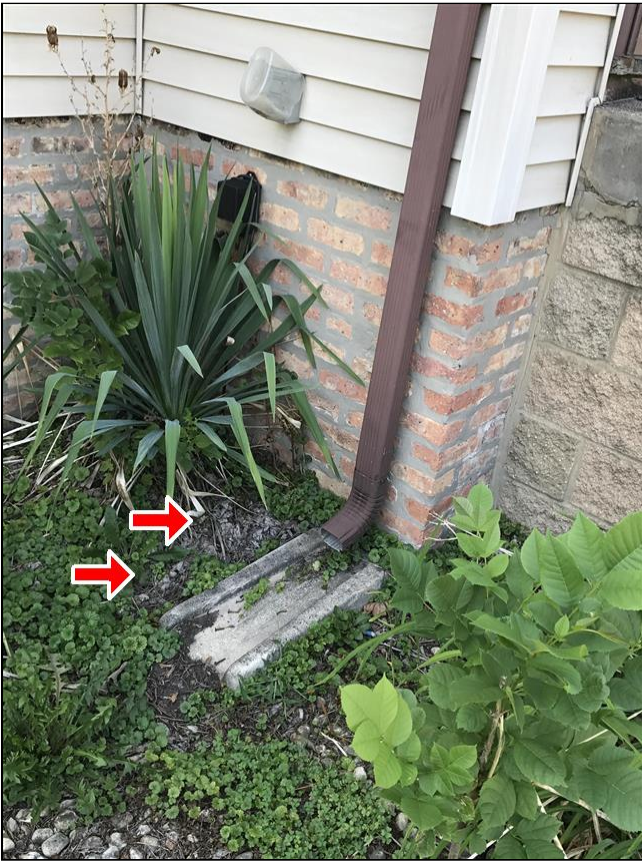
1.7 Item 1(Picture) Downspout drains too close to the building, this can cause uneven swelling of expansive soils and may result in shifting and cracking sidewalks, driveways, and parking lots next to the building. Have a licensed contractor extend downspouts to drain atleast 6 feet from the structure,

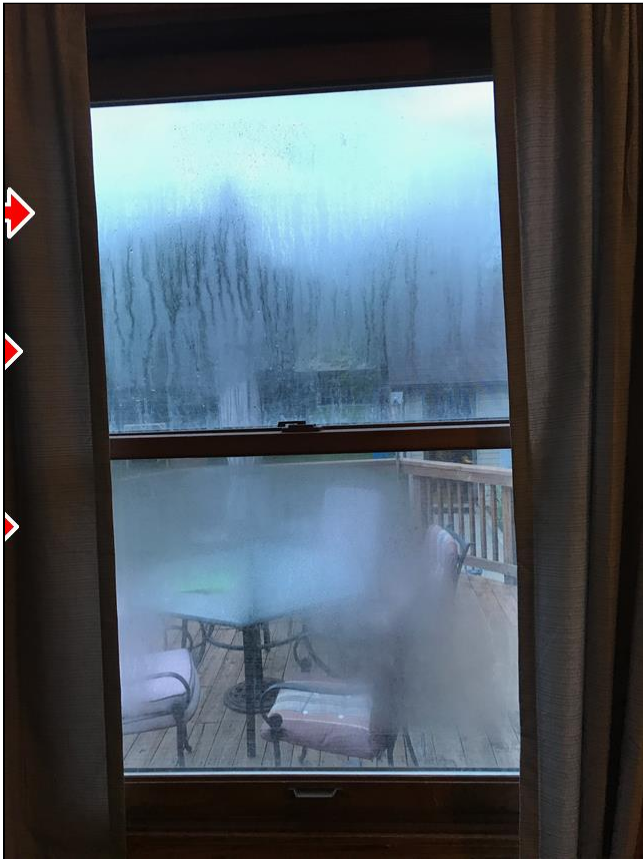
1.11 Item 1(Picture) Window appears to have lost its thermal seal. Have licensed contractor repair or replace as needed.

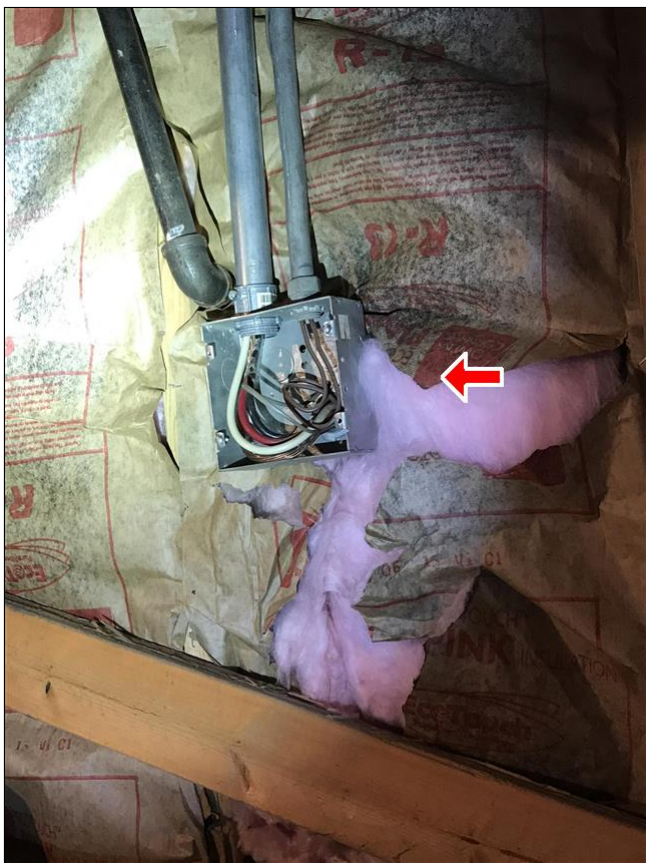
2.3 Item 2(Picture) Open junction box. Have a licensed contractor install cover. Shock hazard.

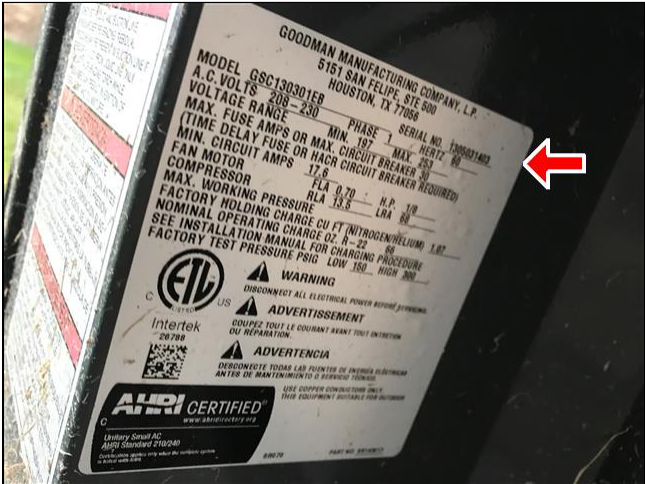
For your information only: Air conditioner was manufactured on 05/2013

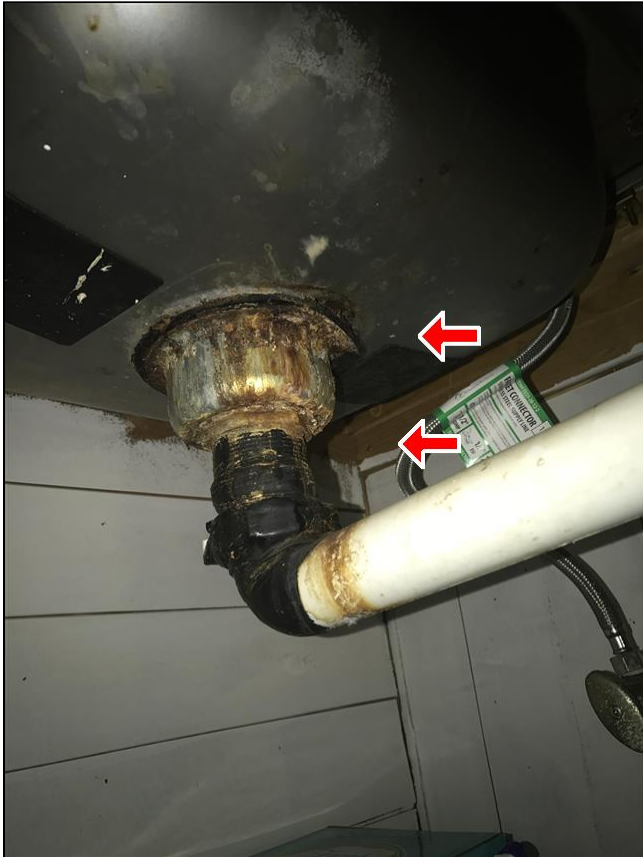
4.0 Item 1(Picture) Corrosion/ signs of old leak.  
Further review by Qualified licensed plumber repair or  
replace as needed.

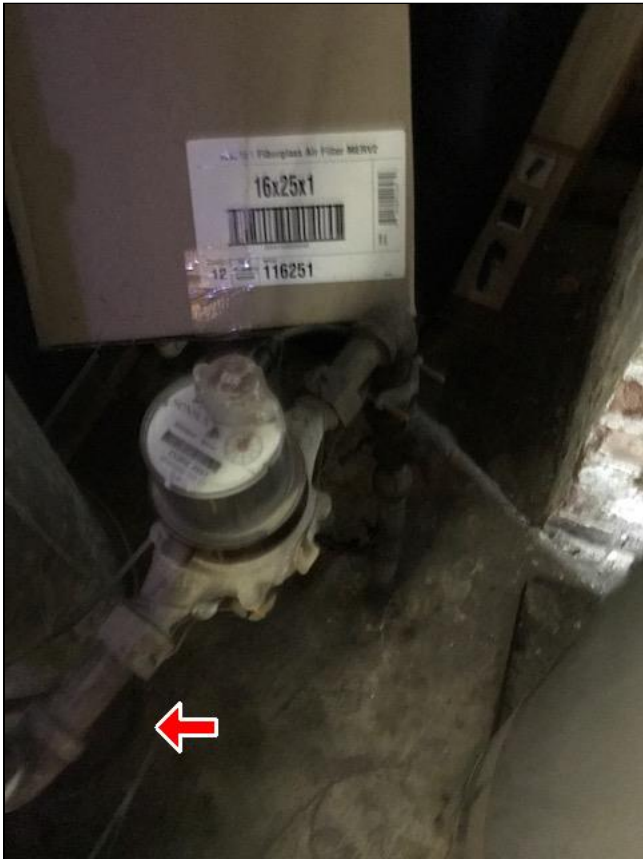
## 4.3

4.3 Item 1(Picture) For your information only: Main water shut off for water, which is located in basemwent next to the water heater. (view partially obstructed due to storage.)

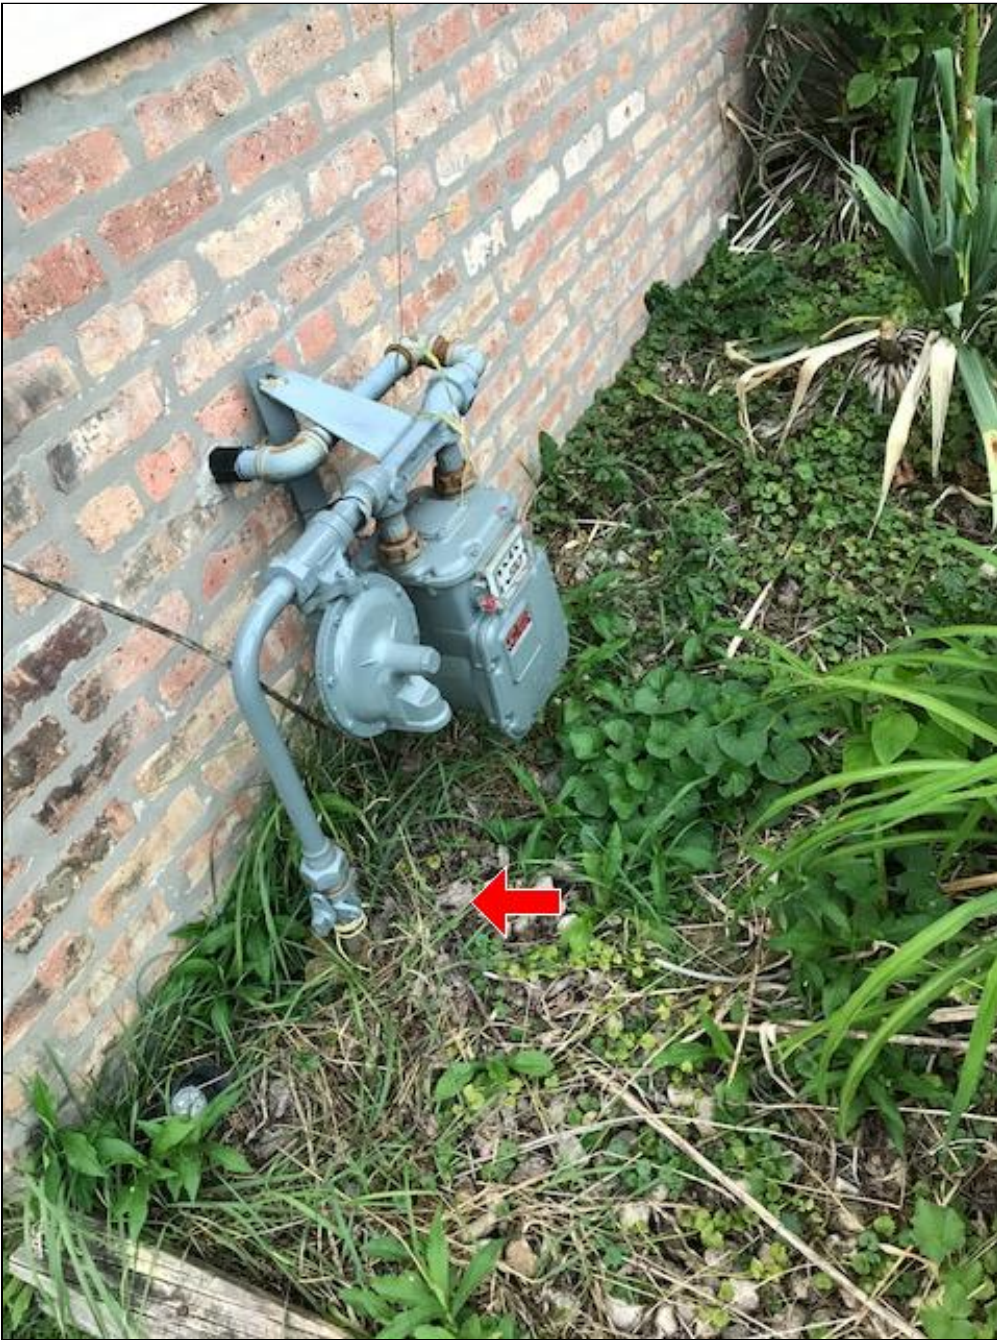
## 4.5

4.5 Item 1(Picture) For your information only: Main fuel shut off for house.

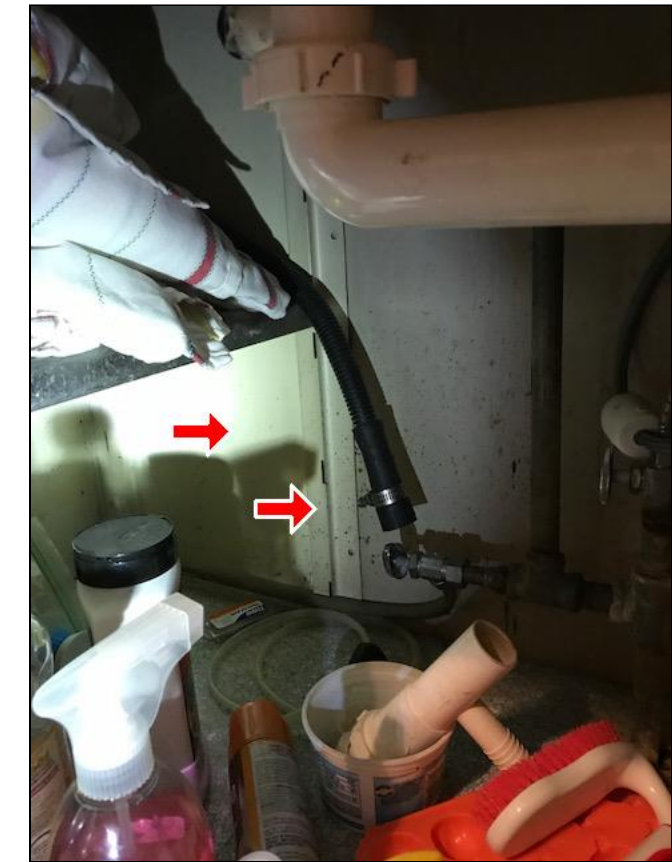
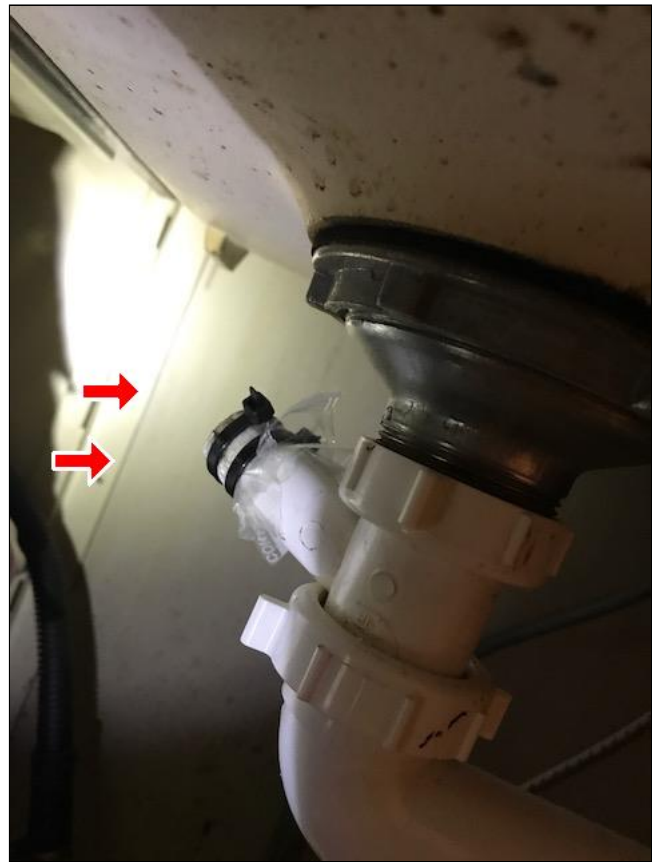
5.0 Item 2(Picture) Dishwasher line disconnected.  
Have qualified plumber repair or replace as needed.

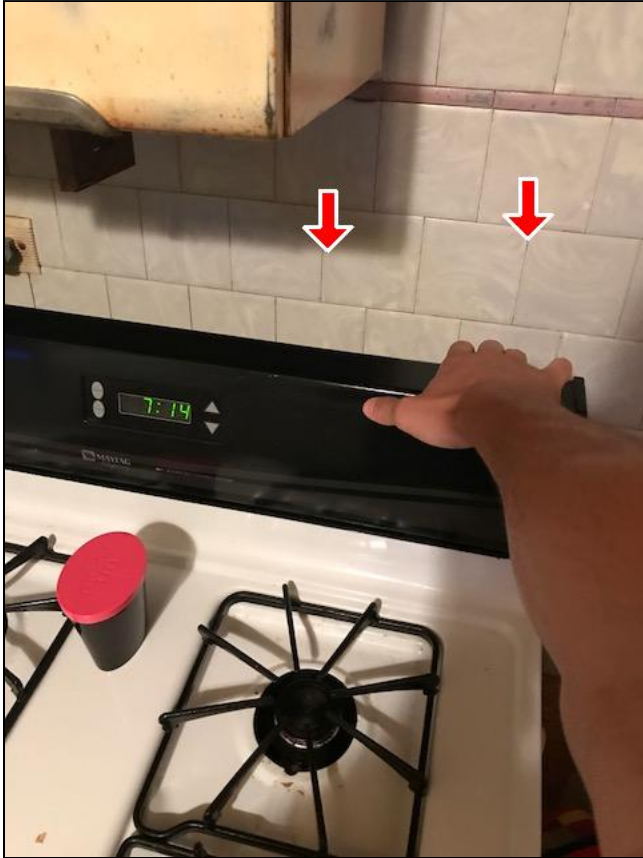
5.1 Anti tip brackets are metal devices that are designed to prevent ranges from tipping. A unit that is not equipped with these devices mat tip over if enough weight is applied to its open door, such as that from a large Thanksgiving turkey, or

5.1 Item 1(Picture) Stove/Range is missing anti tip bracket. Safety hazard.

even a small child. A falling range can crush, scald, or burn anyone caught beneath. Have a licensed contractor install anti tip bracket.

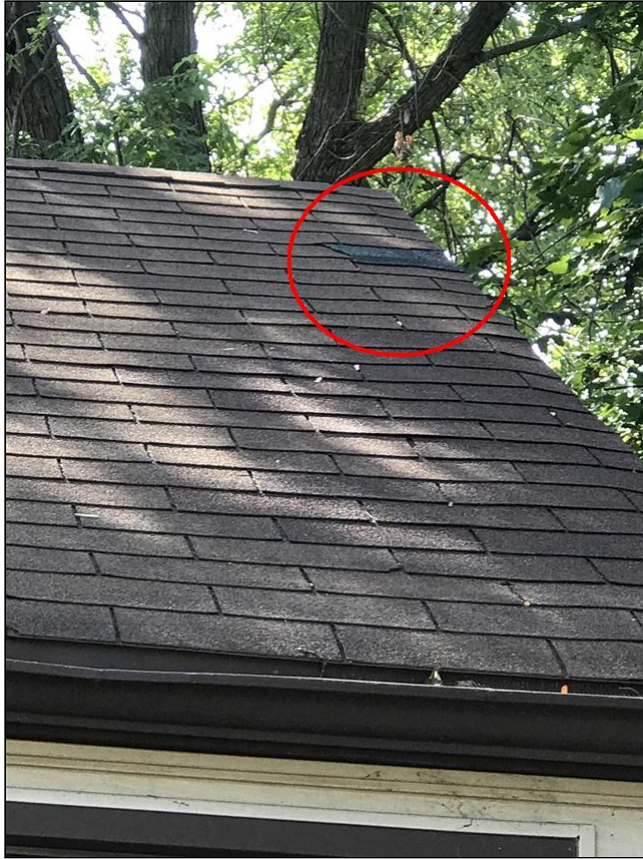
### 1.3 Roof Coverings

1.3 Item 1(Picture) Shingle missing from roof, which can cause water infiltration/deterioration. Have a qualified roofing contractor repair or replace as needed.

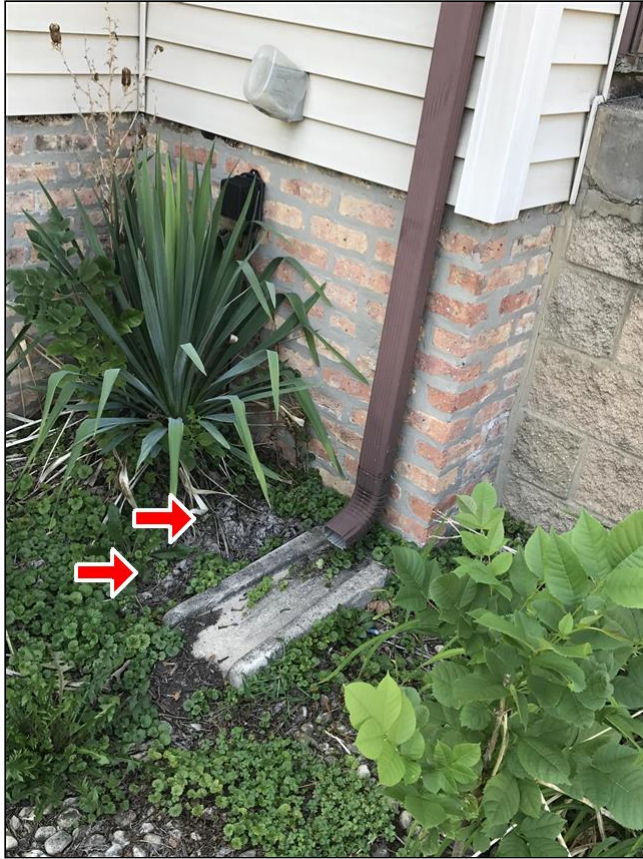
**1.7 Roof Drainage Systems**  
**Inspected, Repair or Replace**

1.7 Item 1(Picture) Downspout drains too close to the building, this can cause uneven swelling of expansive soils and may result in shifting and cracking sidewalks, driveways, and parking lots next to the building. Have a licensed contractor extend downspouts to drain atleast 6 feet from the structure,

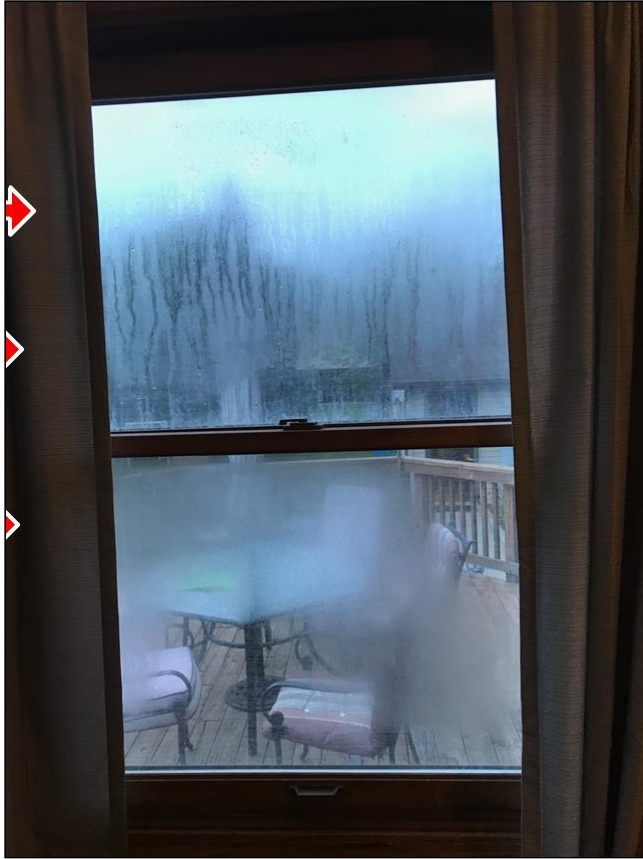
#### 1.11 Windows (representative number)

1.11 Item 1(Picture) Window appears to have lost its thermal seal. Have licensed contractor repair or replace as needed.

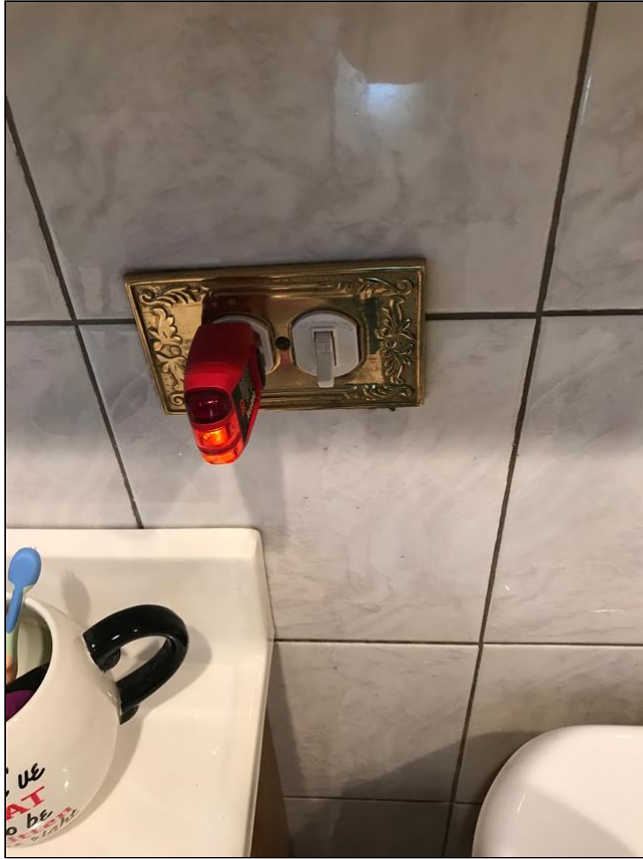
2.4 Item 1(Picture) Areas outside or near any source of water require GFCI. GFCI outlets help prevent accident electrocutions from occurring. Have electrical contractor repair or replace as needed.

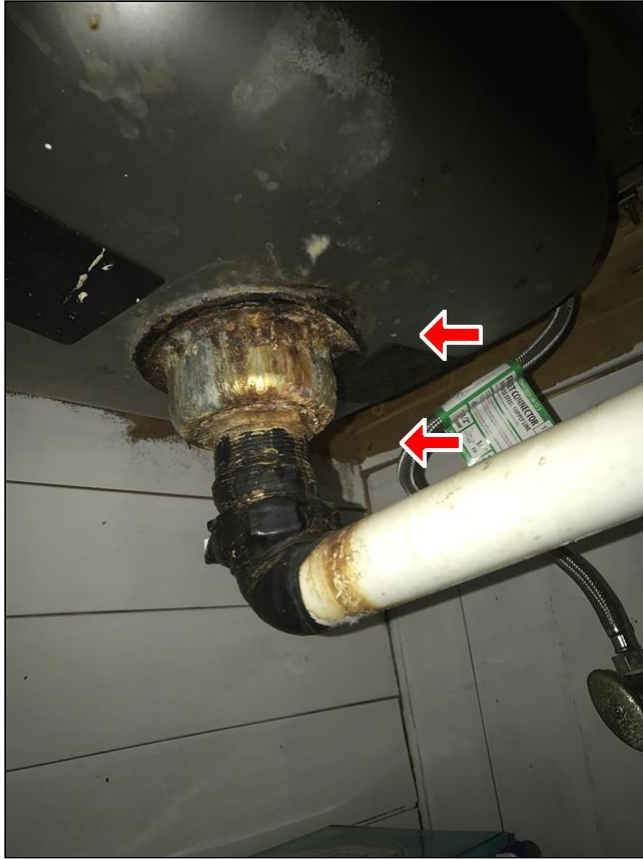
##### 4.0 Plumbing Drain, Waste and Vent Systems

4.0 Item 1(Picture) Corrosion/ signs of old leak.  
Further review by Qualified licensed plumber repair or  
replace as needed.

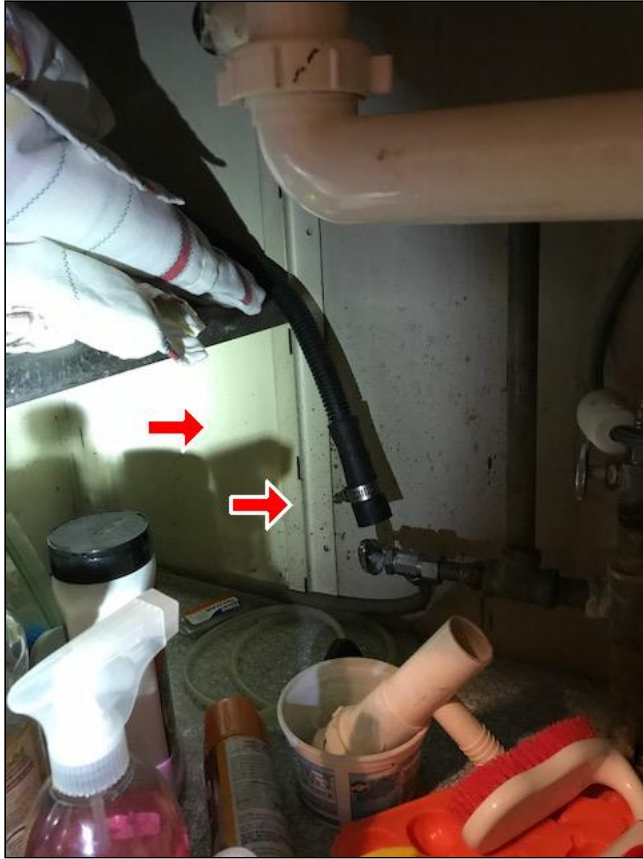
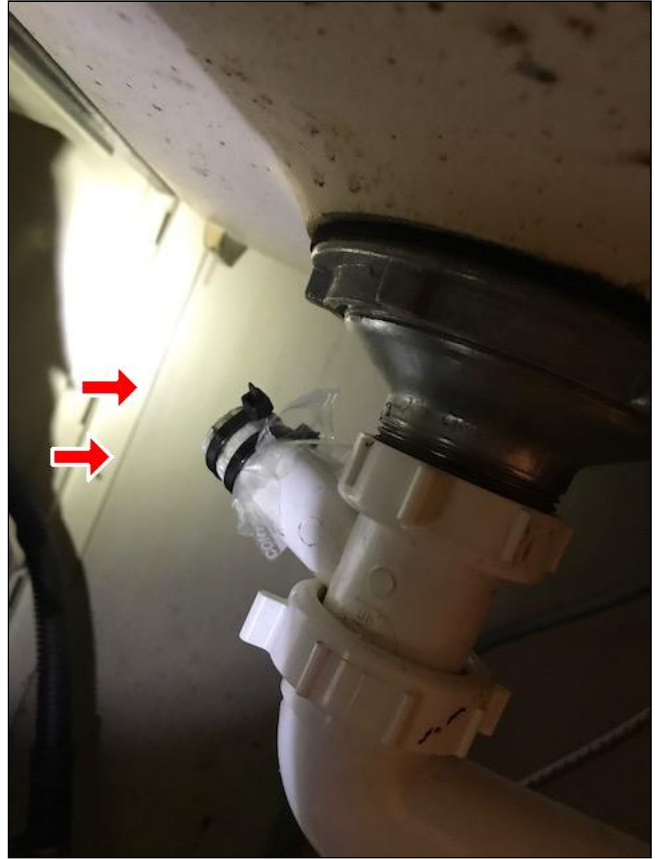
### 5.0 Dishwasher

5.0 Item 2(Picture) Dishwasher line disconnected.  
Have qualified plumber repair or replace as needed.

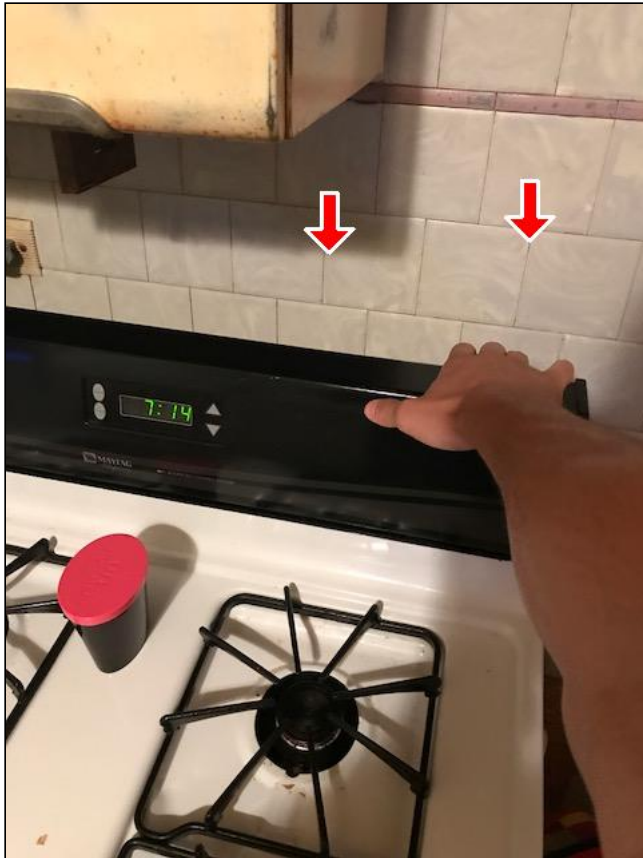
## 5.1 Ranges/Ovens/Cooktops

Anti tip brackets are metal devices that are designed to prevent ranges from tipping. A unit that is not equipped with these devices may tip over if enough weight is applied to its open door, such as that from a large Thanksgiving turkey, or even a small child. A falling range can crush, scald, or burn anyone caught beneath. Have a licensed contractor install anti tip bracket.

5.1 Item 1(Picture) Stove/Range is missing anti tip bracket. Safety hazard.
